Pollett River Habitat Assessment

Alliance du bassin versant
Petitcodiac
Watershed Alliance

Methodology

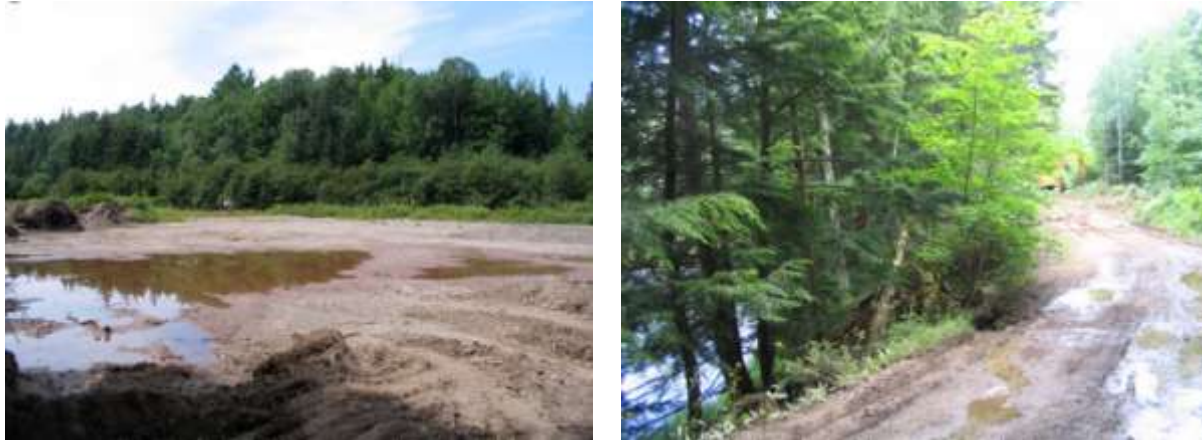
Figure 1 and 2: Damage to Pollett River buffer through removal of gravel (above) and road building activity (above and right) both without the required permits.

The banks of this river are almost entirely forested. But, there is a fair amount of buffer zone damage in some of the more populated sections of the river. Two incidents were reported to the department of the environment during this assessment. In one case a road was being built within the buffer zone of the river without a permit and in another section of river the owner was removing gravel from the riverbank. JD Irving was contacted concerning problems with sediment loading in a tributary of the

Pollett as a result of poor culvert installation on a logging road. Other than that, there are homeowners with sewage issues along the river that we could detect from odors emanating from the shoreline, and homeowners that have destroyed the buffer zone in order to obtain clear views of the river.

The buffer zones along the Pollett River that have been damaged by private landowners should be repaired. The PWA will provide these landowners with information about buffer zones and how they protect the river and provide funding and assistance to make the necessary repairs. There are homeowners along the Pollett River that need to make improvements to their septic and sewer systems. The PWA will visit all homes along the Pollett River and provide information on proper septic system installation and service information.

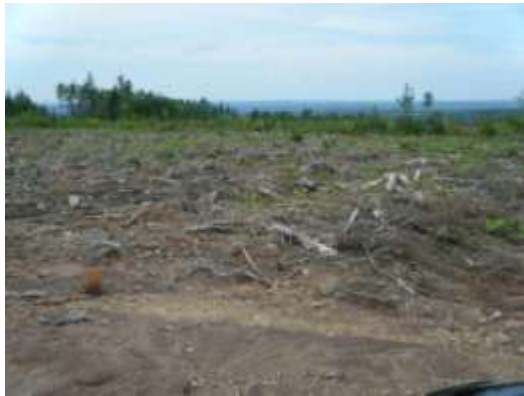
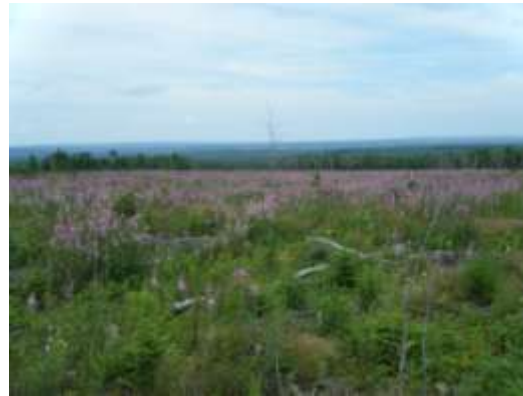
Figure 6 and 7: The volume of clear cutting taking place in the Pollett River watershed may impact water quality and quantity.

There is a significant amount of clear cutting taking place in the Pollett River watershed. Most of the harvesting is done by JD Irving Ltd, although at least one land owner has cleared a large tract of land. It is difficult to determine the acreage of land that is cut on a yearly basis as the only information that we can obtain is the 25 year cutting plan. We have been able to obtain GIS maps that show all Irving forestry activity from 2001 to 2007. The type of deforestation that is taking place is of particular concern. The trees are all cut and put through a chipper, every tree is removed and there is nothing left behind, there are no undesirable species, no limbs and no branches left behind to provide nutrients for the soil or habitat for animals. Large tracts of land are being cleared at a time which also affects the infiltration and runoff of water during precipitation events, the rate of spring melt off and the ability of the watershed to moderate flow rates during extremely wet or dry periods of weather. Poorly designed woods roads and undersized or poorly installed culverts are also potential threats to water quality in the Pollett River watershed.

The Petitcodiac Watershed Alliance will continue to monitor and work with JD Irving to ensure that deforestation does not have a negative long term impact on the aquatic habitat of the Pollett River.

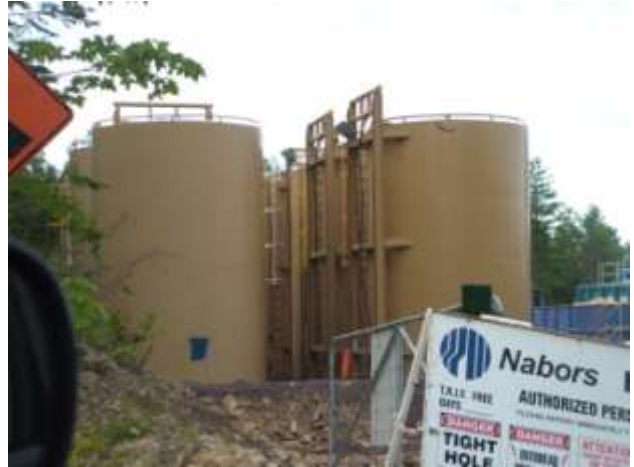
Figure 12 and 13: Natural gas fractionation site, less than a kilometer from the Pollett River.

There are two natural gas wells within the Pollett River watershed. Natural gas fractionation has the potential to have a negative impact on the Pollett River watershed, especially as a greater number of wells are drilled. Some of the risks associated with shale gas fractionation include: freshwater extraction from local streams, habitat destruction, and sediment deposition from the construction of dirt roads, wastewater spills and chemical contamination of surface waters.

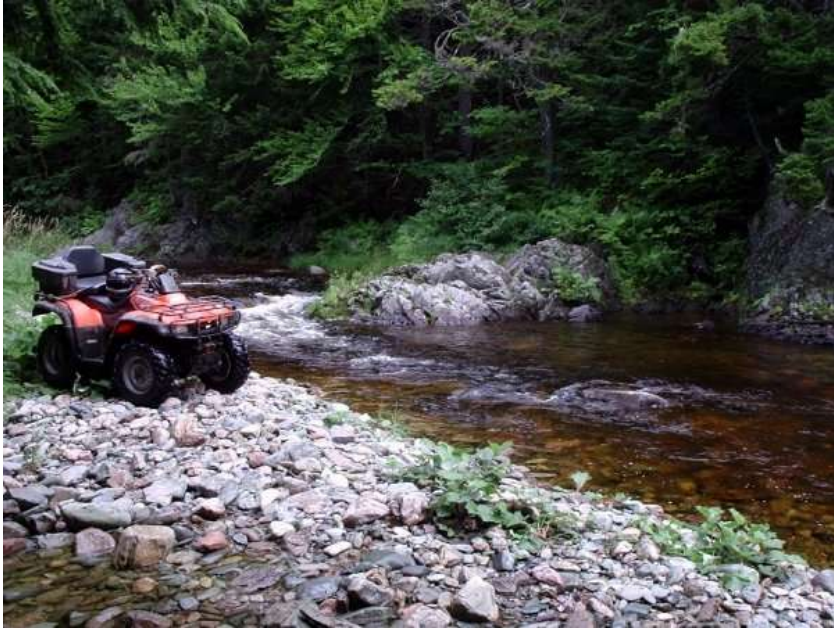
Figure 10: Recreational users of the river can also cause localized damage to streambeds and shorelines and this can lead to sediment or erosion problems.

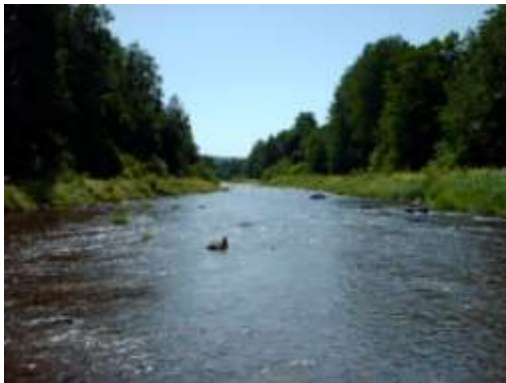
Site 2: Downstream

Comments: A four wheeler trail crosses the river here and this has damaged the true right bank. The river is wide and shallow, it divides itself to go around an island. Substrate is boulders, cobble and some sand. Water is clear and clean. This section of stream is all riffles and no pools. Wide variety of macro invertebrates: caddisflies, mayflies, dragonfly larvae, worms, damselfly larvae, blackfly larvae, leeches.

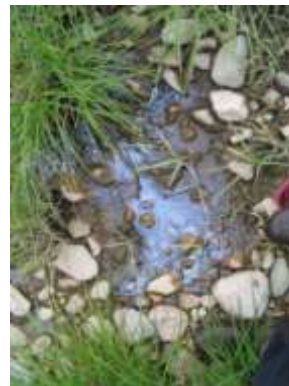
Site 7: Natural Oil

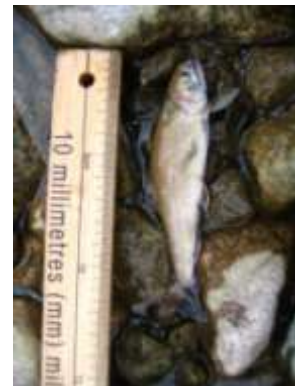
1 Dead Trout

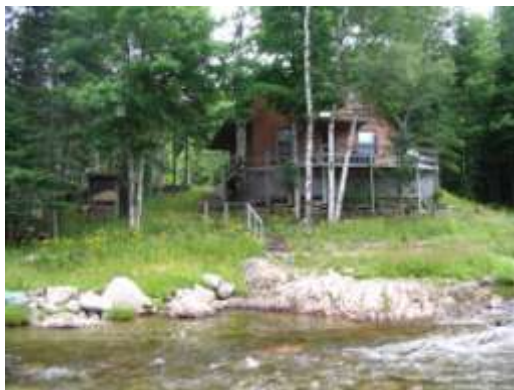
Substrate consists of rocks and gravel. Water is clear and clean. Some bank erosion, but the grass and shrubs are stabilizing ground. A lot of algae beginning to appear along the banks. Residents are taking water from the river and dumping waste over the bank. One resident mows grass to the riverbank.

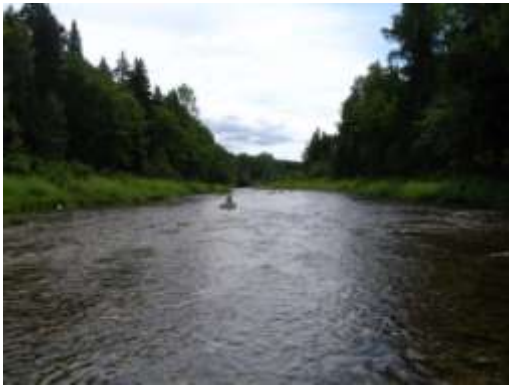
Site 8: Up stream

Camps are encroaching riverbank. Lawn mowed to river edge. Substrate consists of large rocks. Banks appear stable. Small stream enters here. Algae on the rocks. Stream channel has been altered, a dam has been built here to provide deeper water for swimmers.

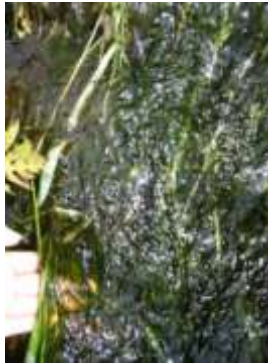
Algae coming from a ditch at a cottage.

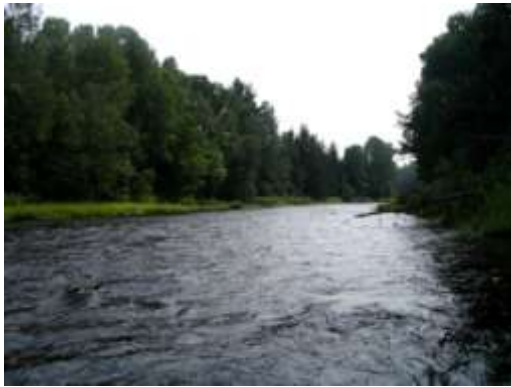
Site 22: Up Stream

Located in the back of the grey house. There's some clear cutting, erosion and garbage between site 21 and 22 close to the river. There's lawn on one side of the river. Clear cutting on other side with some buffer damage. Substrate consists of boulders, rocks and sand. The first house before the Girl Guide camp has a bad sewage problem – you can smell it on the river.

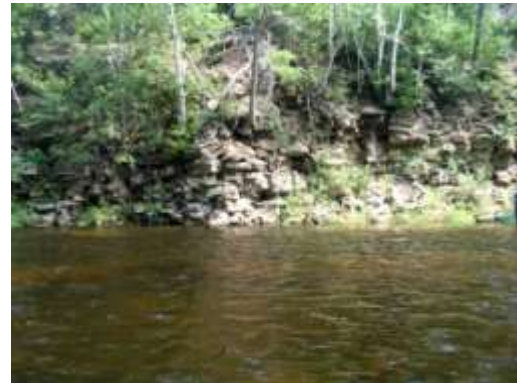
Slight erosion between site 21-22

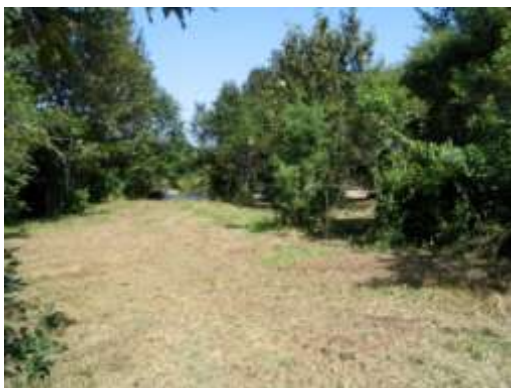
Stream enters river between site 35-36

There's a stream coming in the river between site 35 and 36. Someone destroyed a huge part of the riparian zone (lot for sale sign). Tall grass on banks. Substrate consists of boulders and gravel embedded.

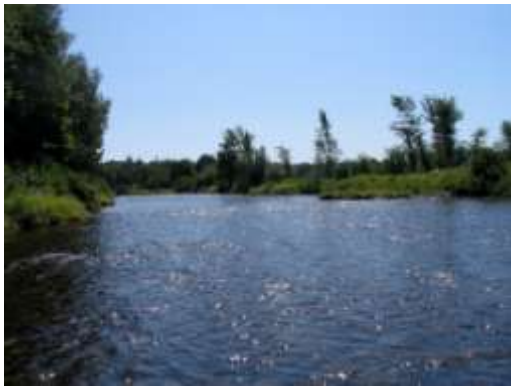
Site 41: Up Stream

Tall grass on both sides. Substrate consists of boulders, rocks, rubbles and gravel. Zero shade on the river. Clear cutting between site 40 and 41. The riparian zone and wetland on the true right bank has been damaged, looks like it is being mowed with a bush cutter.

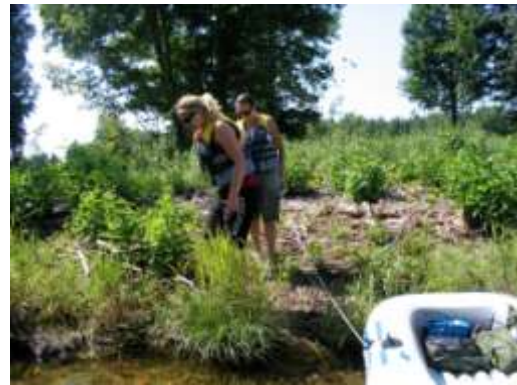
Damage riparian zone between site 40-41

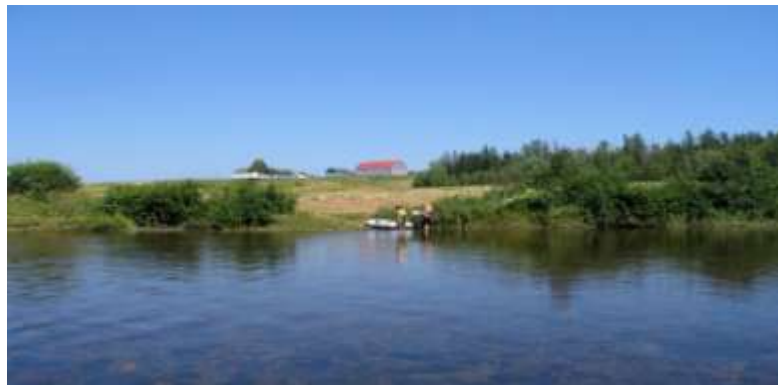
Site 44: Across (clear cutting)

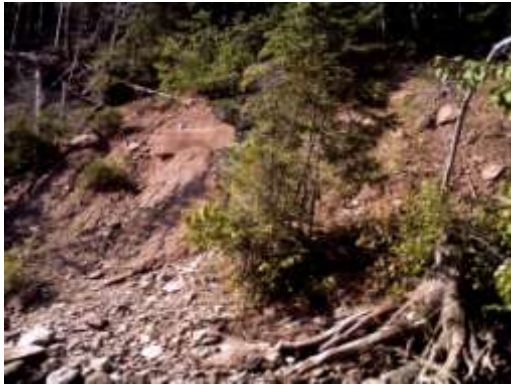
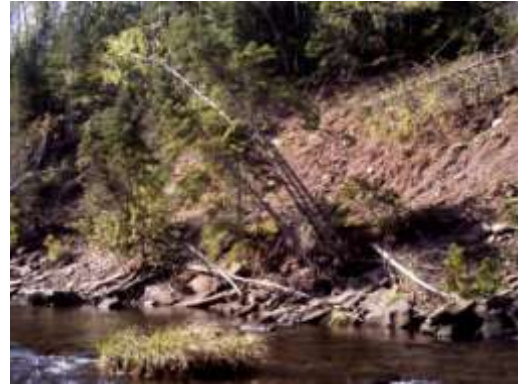
Erosion between site 52 and 53

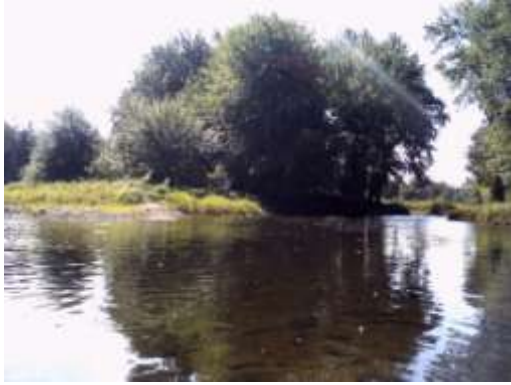
Big pool between site 53-54

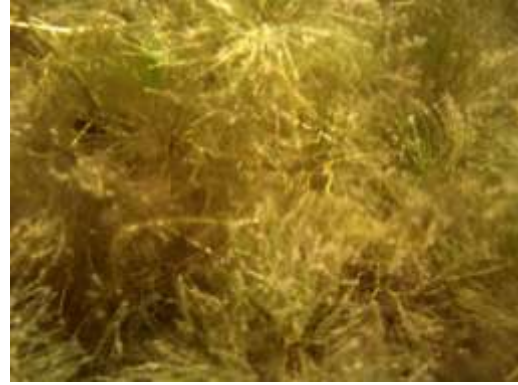
Algae between site 53-54
