**PROJECT REPORT (2004)
WILDLIFE TRUST FUND**

INTRODUCTION

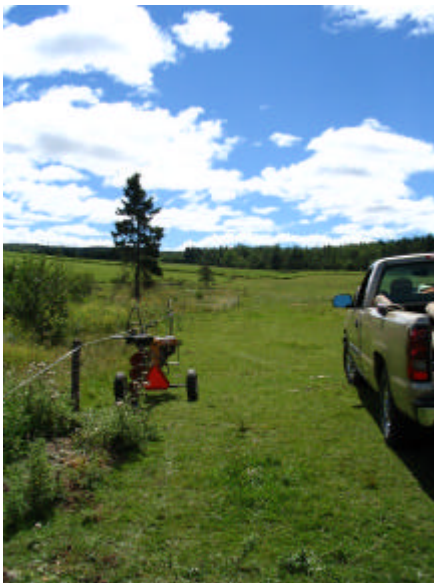
A manually operated hydraulic auger was rented from The Home Depot© and holes were dug approximately 6 meters apart along a temporary electrical fence originally installed by the farmer. Cedar posts were dropped in the holes and stabilized with the earth that was extracted with the auger. Once the posts were in, three rows of barbed wire were stapled to the post and tightened using a wire puller provided by the farmer. Finally a windmill was installed with the help of the farmer. Installation of this assembled windmill was fairly simple. This project took over a week to complete.

Before

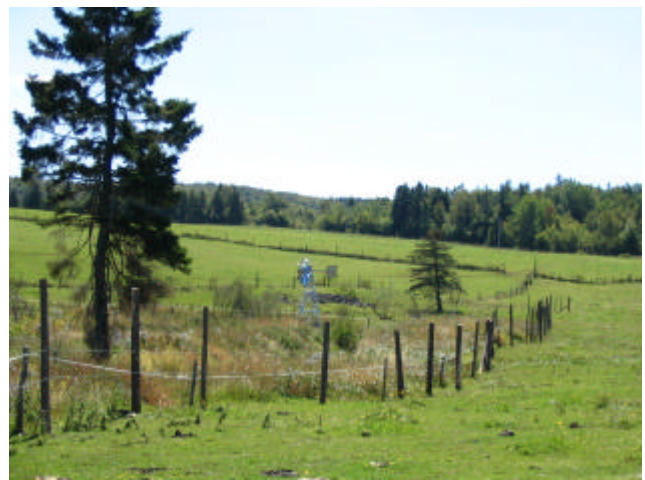
After

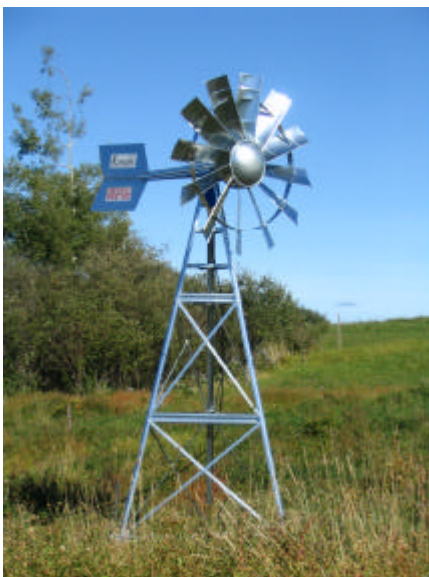
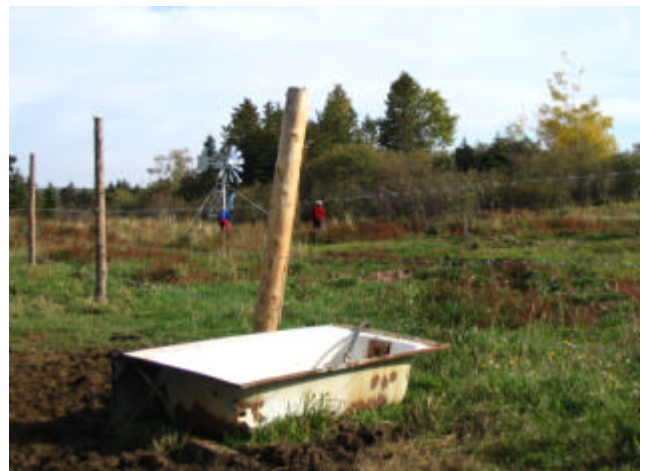
Windmill and tub

- Regular maintenance of the fence and windmill are the only recommendations associated to this site.
- The farmer should continue working on recommendations outlined within his environmental farm plan.

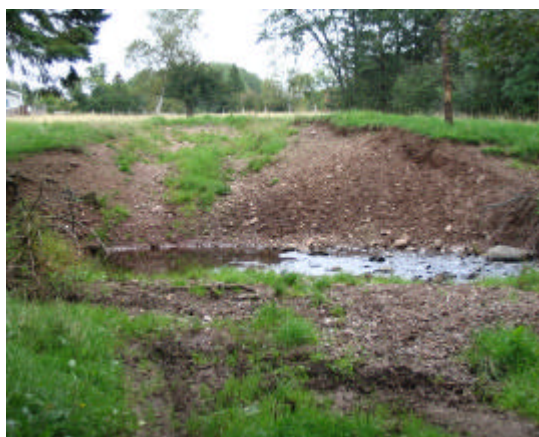
At this location, because the soil was very hard and rocky we had to hire a local entrepreneur to dig the holes using an auger attached to a farm tractor. Sixty-two holes were dug at eight dollars a hole in less than three hours using that method. After the cedar posts were dropped-in and stabilized. Three rows of barbed wire fencing were stapled to the posts. Since the wire puller provided by this farmer wasn't working very well we purchased a ratchet system that worked perfectly. After the fence was installed we had 20 tons of 3-6" crushed stone delivered and we hired the service of a local backhoe operator to reduce the approach angle on the fording site. We then spread a layer of geo-textile fabric and the backhoe operator spread the crushed stone for the two approaches to the stream. The stream bed was already stable so it was unaltered. Eroded stream banks were also stabilized with Geo Jute© This project also took over a week to complete.

Before

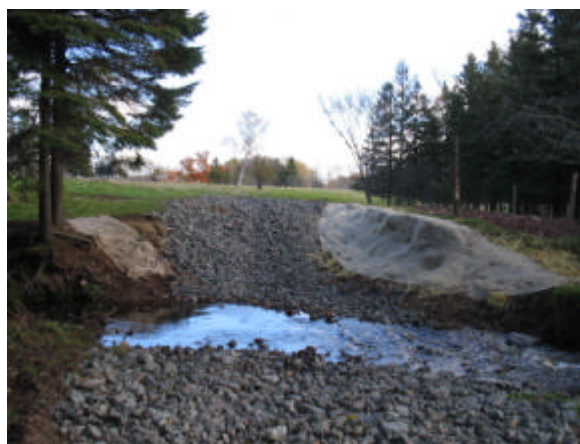
After

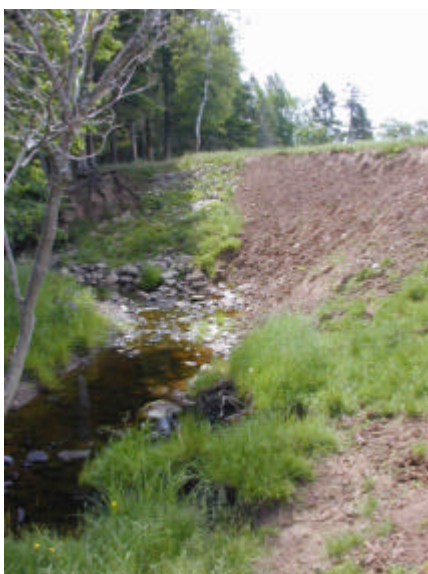
Before

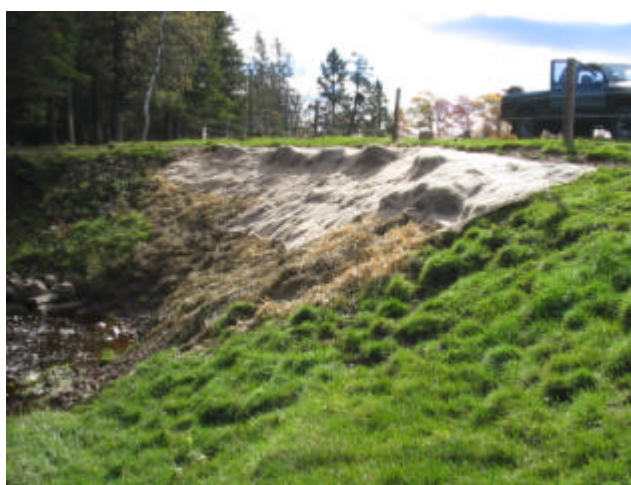
After
